This project was highly commended amongst the entrants for the 2018 King of Prussia Gold Medal Award

Old Chapel was built for a Presbyterian congregation between 1839 and 1845 to the designs of architect Richard Tattersall of Manchester, replacing an earlier chapel built in 1707. A temporary porch at the west was eventually replaced in the 1890s with a new west front to the designs of Worthington & Elwood in neo-Gothic style, with several fine Capronnier windows. Over the years the beliefs of the congregation changed from Presbyterianism to Arianism and then, in the mid C19, Unitarianism.

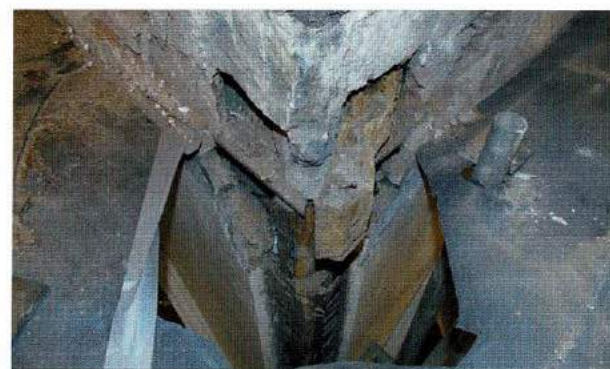
Original timber support to plaster vault springing point

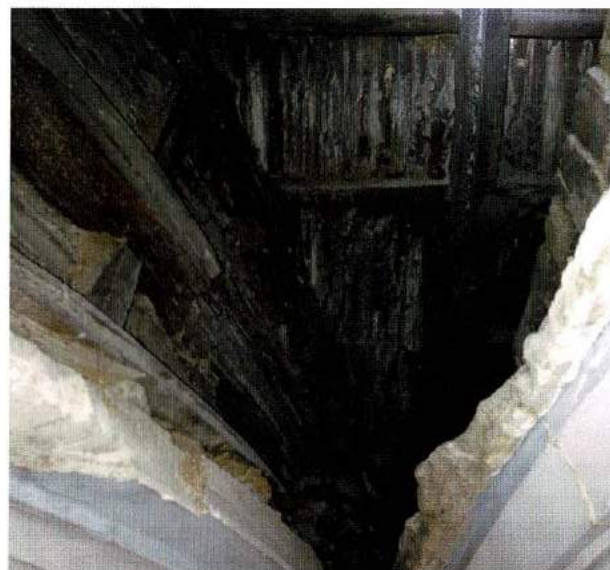
were about 10 tonnes of unsupported plaster: the chapel had to be immediately closed and a temporary structural supporting scaffold installed. While this was being installed, it was found that the timber columns clad a cast iron structure. Water was entering the roof space from failing hoppers and travelling down the column cores into the floor voids. This raised considerable concern as to the potential extent of the dry rot throughout the chapel.

Interior of vault; complete loss of timber rib and laths

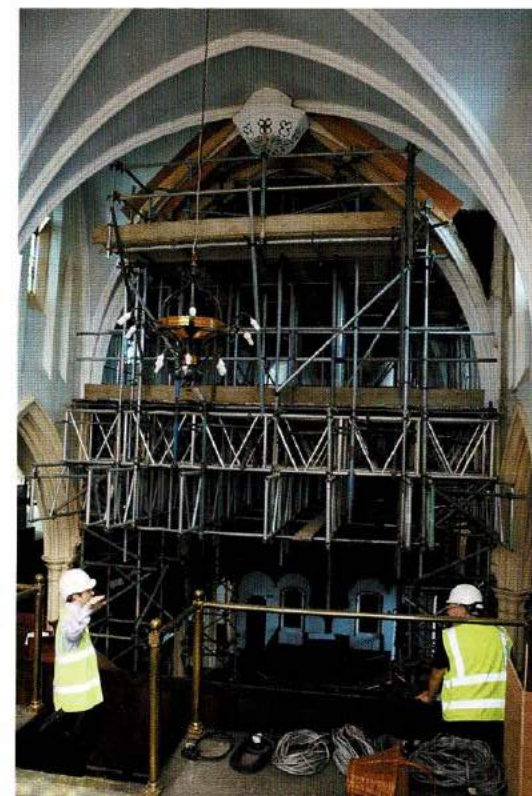
Supporting scaffold to plaster ceiling

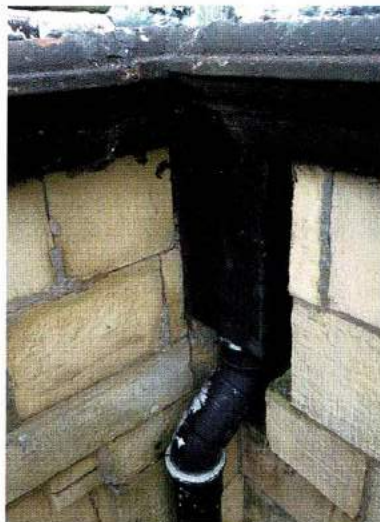
blocked hoppers and downpipes due to their design inset into the walls. The interior had been recently redecorated and appeared in reasonable condition though some water staining and cracking was noted at the intersection of the transept and nave vaulted plaster. A key recommendation in his report was that a detailed high level inspection of these areas should be undertaken. In June 2014 the owners carried out some opening-up works. These identified that water had indeed been entering the building due to the poor design of the rainwater disposal system, causing dry rot outbreaks which had completely destroyed four key timber bearings to the central crossing of plaster vaulting, as well as localised sections of timber wallplates and roof truss bearings.

Original gutter let into masonry

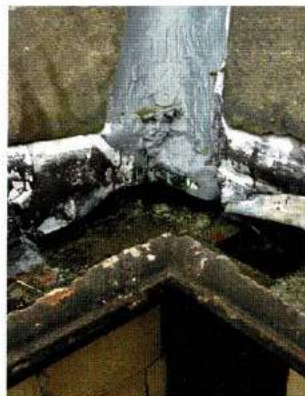
Original gutter intersection and outlet
